TECHNICAL REPORT HL-79-17

NAVIGATION CONDITIONS AT THE UPSTREAM APPROACH TO LOCK AND DAM NO. 3 MISSISSIPPI RIVER

Hydraulic Model Investigation

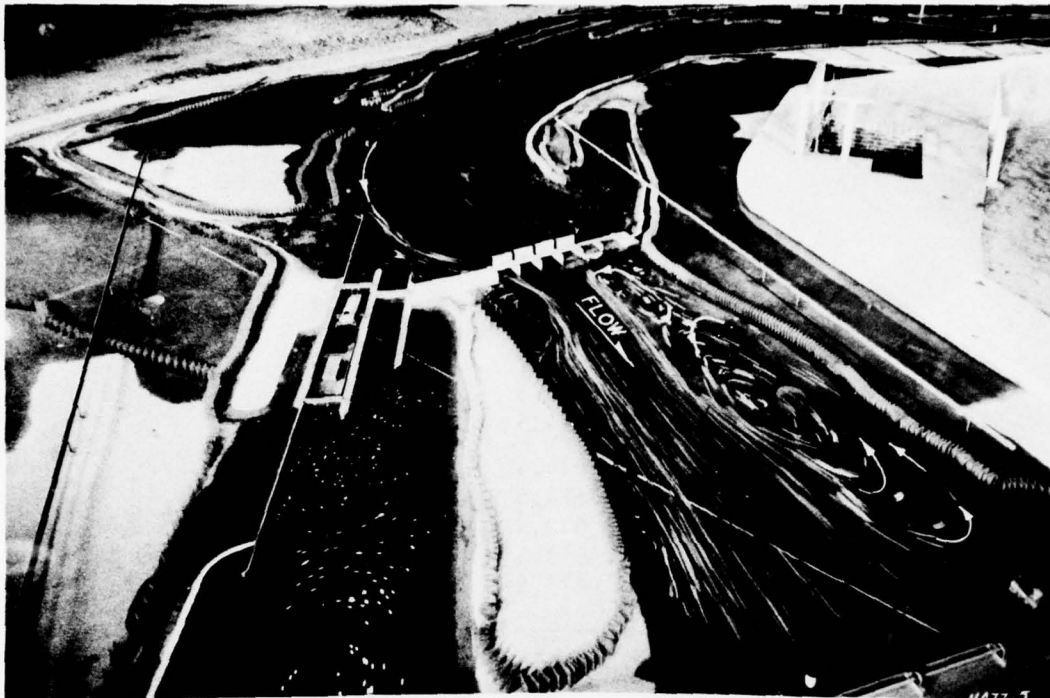
a. Surface currents in lock approach and in approach to gated dam

b. Path of 600-ft downbound tow approaching lock guide wall with existing conditions. Note tendency for tow to be moved away from guide wall

Photo 1. Base test; discharge 36,000 cfs, upper pool el 674.0
(Sheet 1 of 2)

24. Because of the set of the currents moving from along the right bank toward the spillway, navigation conditions for downbound tows were extremely difficult and hazardous even with the low flows tested. Downbound tows attempting to approach the guide wall would tend to be moved riverward by currents moving toward the spillway (Photo 1b). Downbound tows reaching the guide wall would tend to have their stern moved riverward unless mooring lines are attached to the wall. Upbound tows leaving the lock would also tend to be moved riverward, but no

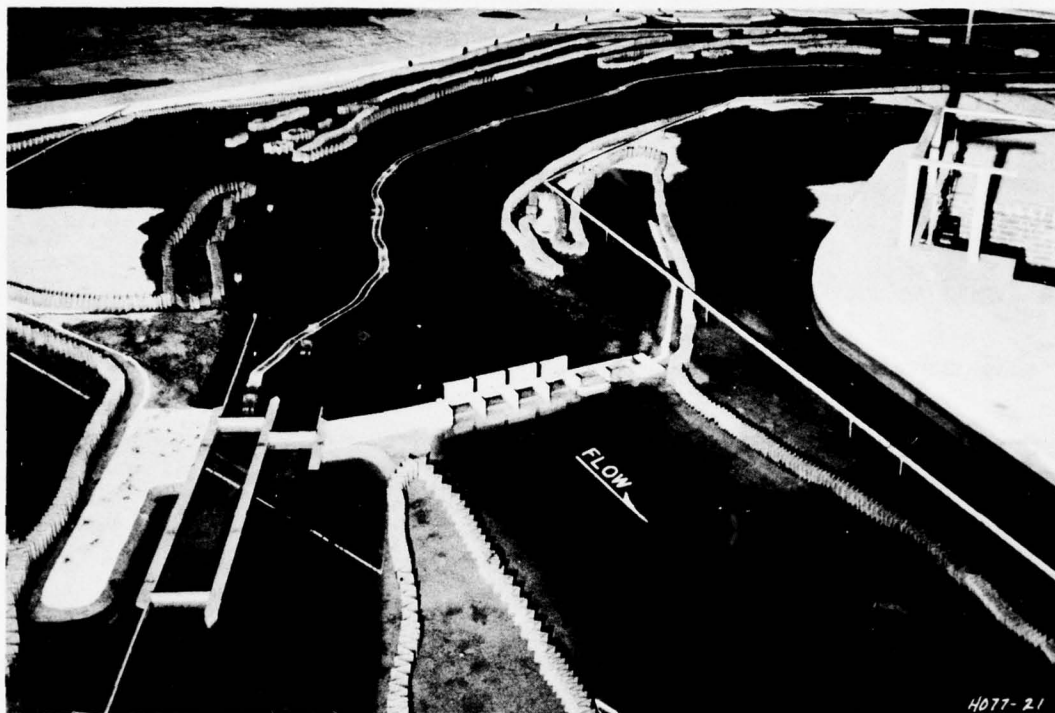
c. Path of 600-ft upbound tow leaving lock showing effects of crosscurrents on head of tow

Photo 1 (Sheet 2 of 2)

serious difficulties were indicated for tows having sufficient power and steerage to overcome the effects of the currents (Photo 1c).

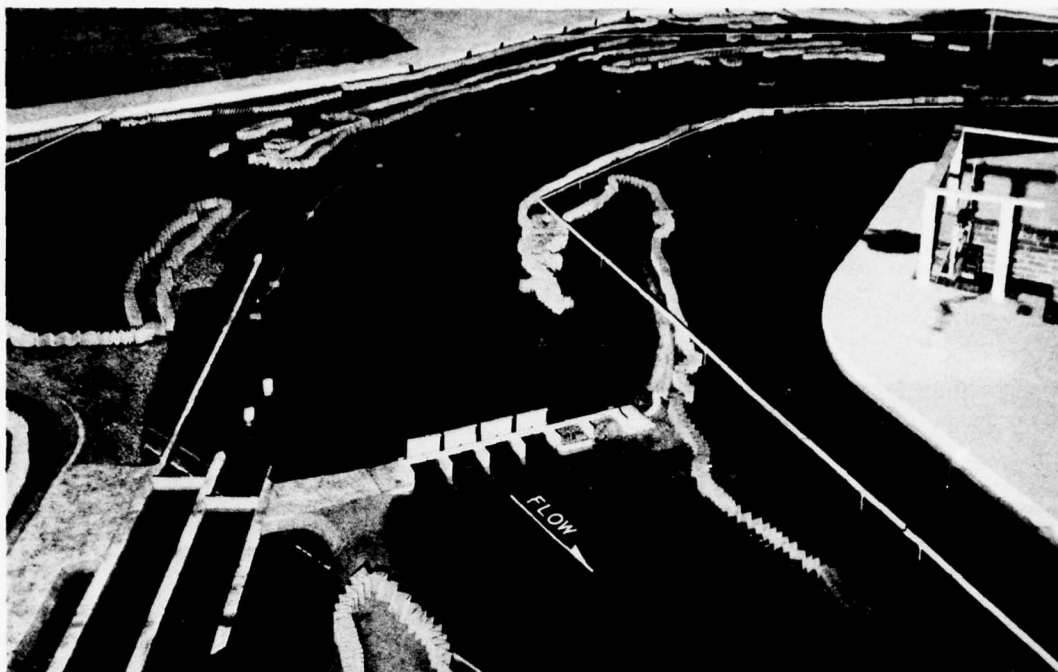
a. Path of downbound 600-ft tow approaching extended guide wall at a slight angle to wall. Note tendency for tow to be moved riverward after passing end of wall

b. Path of downbound 600-ft tow approaching extended guide wall at a slight angle to wall. Note tendency for tow to be rotated clockwise

Photo 2. Existing conditions-modified; discharge 36,000 cfs, upper pool el 674.0 (Sheet 1 of 2)

27. Because of the alignment of the currents along the guide wall extension, downbound tows could approach the guide wall with less difficulty than with the existing wall. However, the head of the tow would tend to be moved riverward by the crosscurrents a short distance downstream of the end of the wall (Photo 2a). Although navigation conditions for downbound tows would be somewhat better than those with existing conditions, the attachment of mooring lines would be required to maintain the position of the tow along the wall and to control its movement along the wall for entrance into the lock (Photo 2b). The modifications had little effect on navigation conditions for upbound tows leaving the lock (Photo 2c).

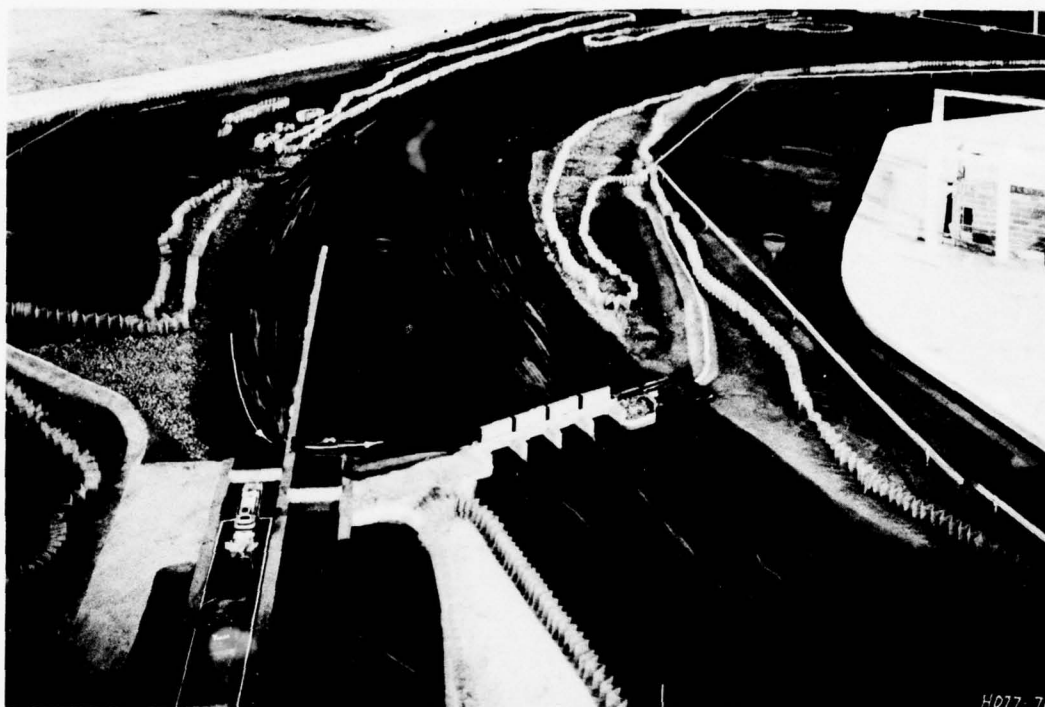
Photo 3. Plan A-modified; discharge 36,000 cfs, upper pool el 674.0.
Surface currents in approaches to lock and dam. Note flow through
the ice gap in upper guard wall

32. With the guard walls of plan A and plan A-modified, there would be a tendency for most of the floating debris and ice moving along the right bank to drift into the lock approach. The ice and debris gap in the guard wall would be effective in passing a considerable amount of flow and most of the loose ice and debris entering the lock approach, particularly with the longer wall (Photo 3).

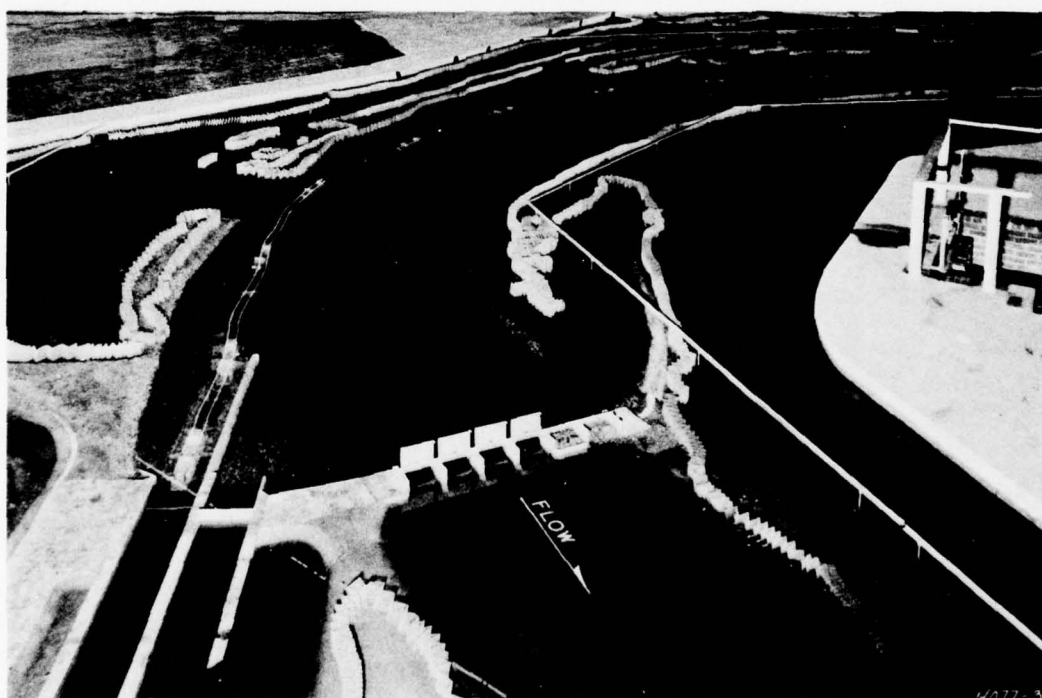
a. Path of downbound 600-ft tow approaching lock

b. Path of upbound 600-ft tow leaving lock

Photo 4. Plan A; discharge 36,000 cfs, upper pool el 674.0

33. Navigation conditions in the upper lock approach were considerably better with the guard walls than with the existing or modified guide wall. Tows properly aligned along the right bank could drift into the lock approach with little or no maneuvering (Photos 4a and 5a). Conditions were better with the longer wall, particularly for tows longer than 600 ft. Flow through the ice and debris gap would have little effect on large tows but could be hazardous for small boats, and a closure or barrier might be required when not passing debris and ice. Conditions were also better for upbound tows leaving the lock (Photos 4b and 5b).

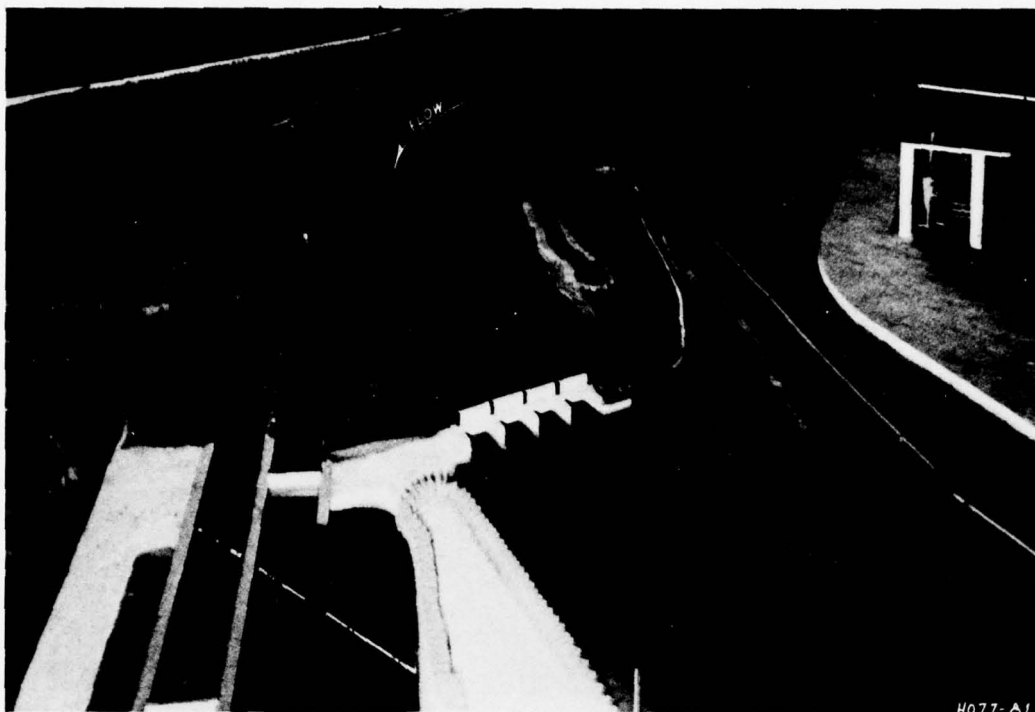
a. Path of downbound 1,200-ft tow approaching lock

b. Path of upbound 1,200-ft tow leaving lock

Photo 5. Plan A-modified; discharge 36,000 cfs, upper pool el 674.0

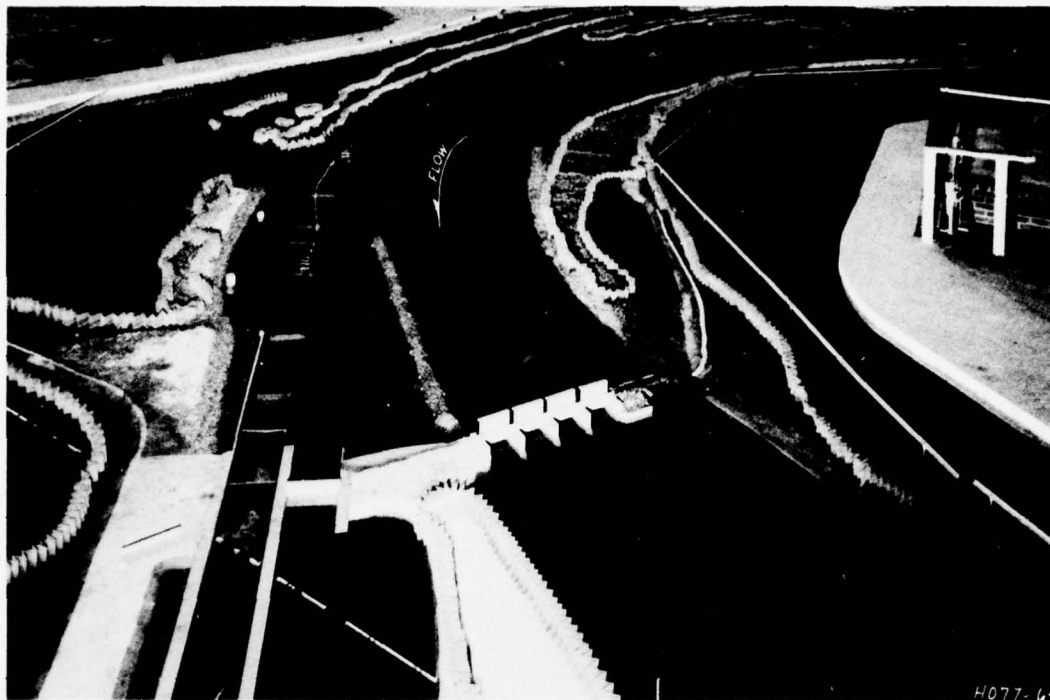
a. Path of 1,200-ft downbound tow approaching lock

b. Path of 1,200-ft upbound tow leaving lock approach

Photo 6. Plan H-modified; discharge 36,000 cfs, upper pool el 673.7
